# Debris/Ice/TPS Assessment And Integrated Photographic Analysis For Shuttle Mission STS-53

DEBRIS/ICE/TPS ASSESSMENT  
AND  
PHOTOGRAPHIC ANALYSIS  
OF  
SHUTTLE MISSION STS-53

December 2, 1992

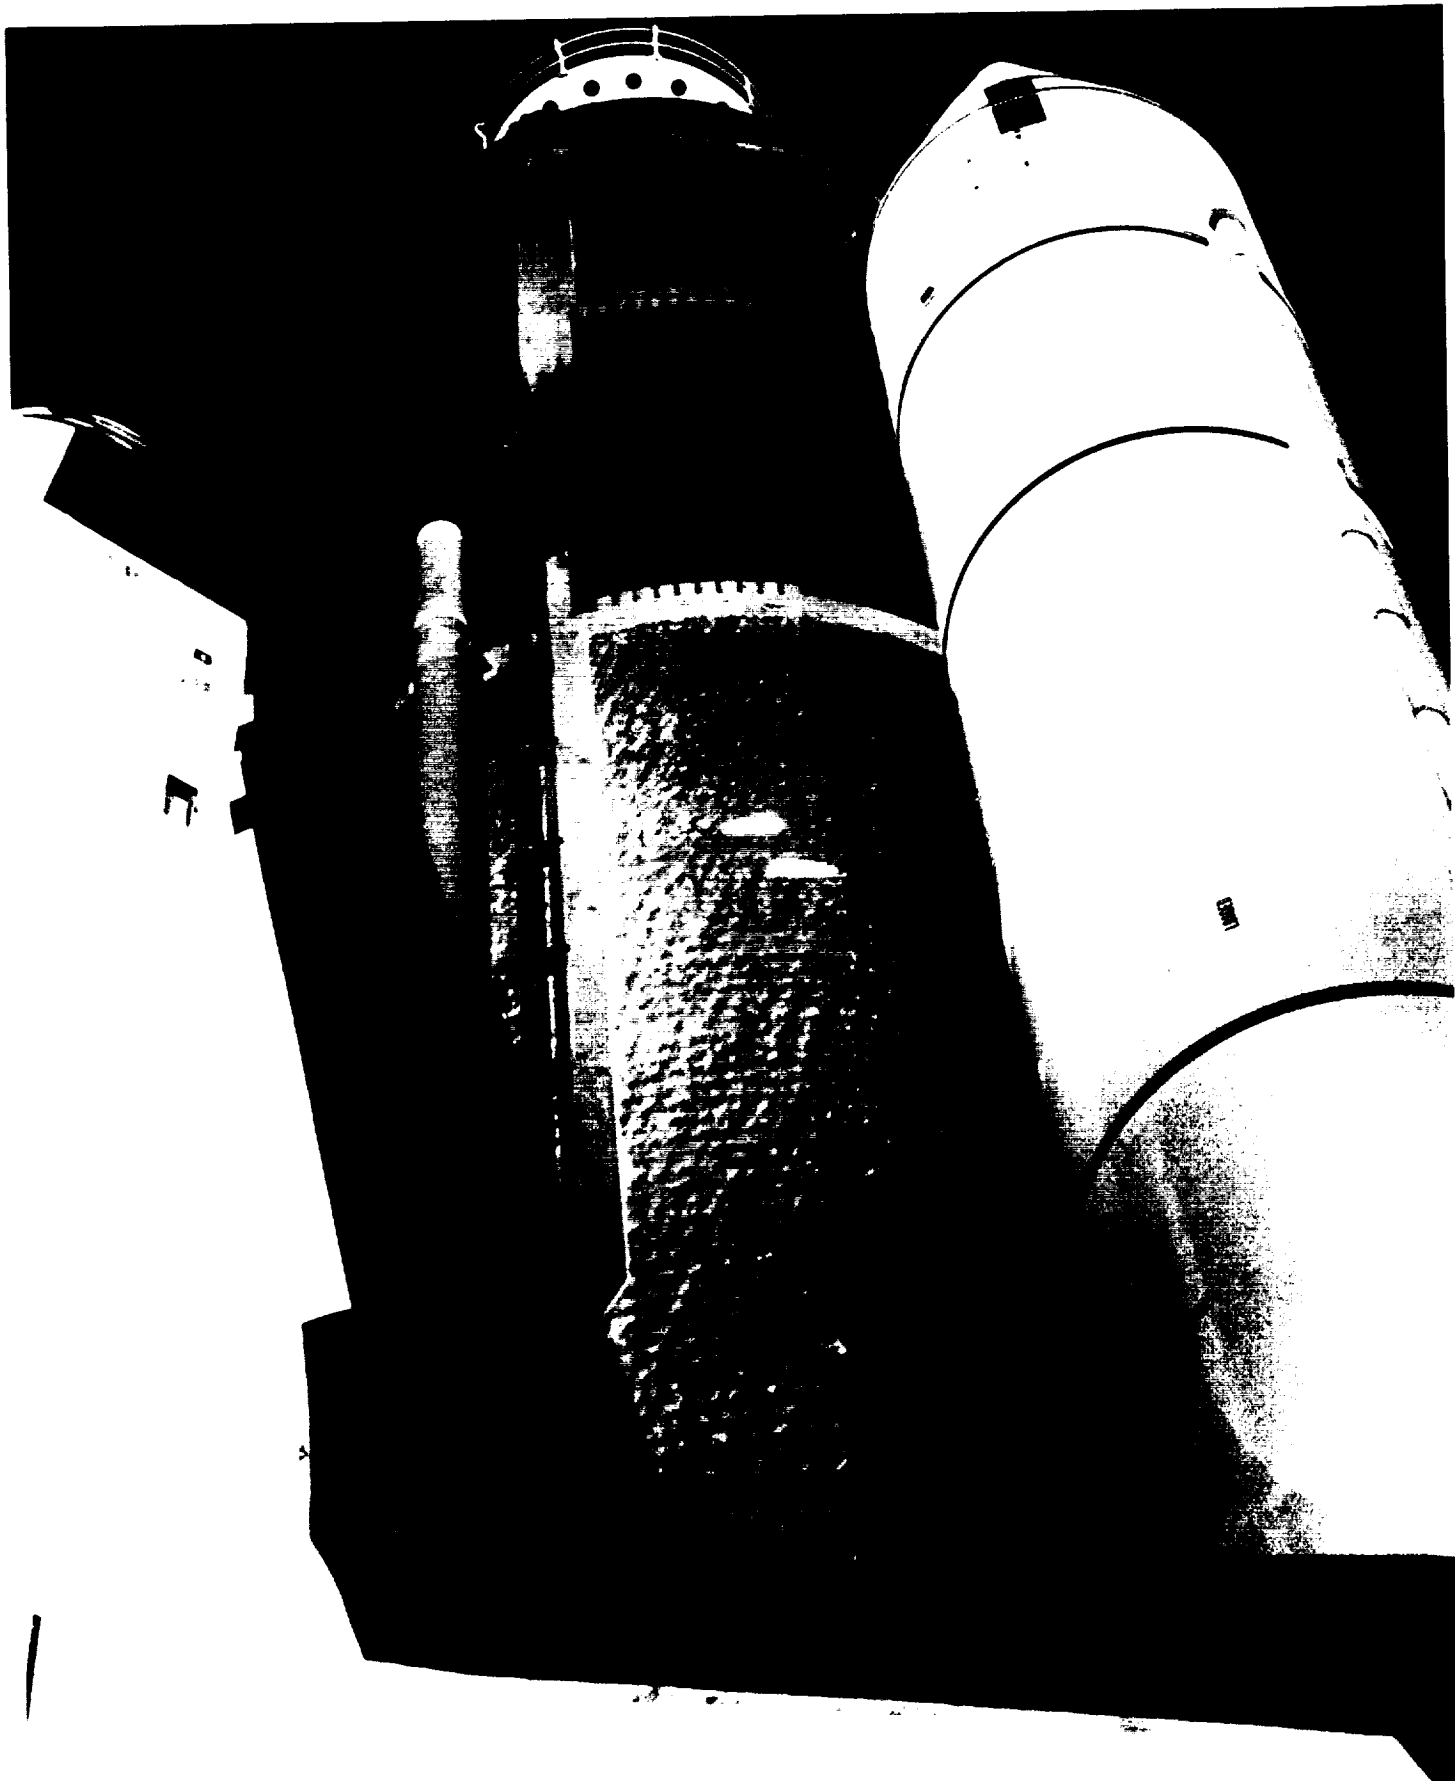
There were no LH2 tank TPS acreage anomalies. At the time of the Ice Inspection, condensate on the LH2 tank +Y+Z quadrant was freezing and changing to ice with a frost covering. Visually, the ice thickness appeared to exceed the 1/16 inch allowed in the LCC. Two sanded areas at XT-1250 and XT-1500 had a heavier coating of ice/frost due to the somewhat thinner TPS. Early in the inspection, the portable STI measured surface temperatures as low as 32 degrees F on the upper LH2 tank and 24 degrees F on the lower LH2 tank. SURFICE predicted temperatures of 25 degrees F on the upper LH2 tank and 32 degrees F on the lower LH2 tank.

At the time of the Ice Inspection, condensate on the LH2 tank +Y+Z quadrant was freezing and changing to ice with a frost covering. The ice thickness exceeded the 1/16-inch allowed in the LCC.

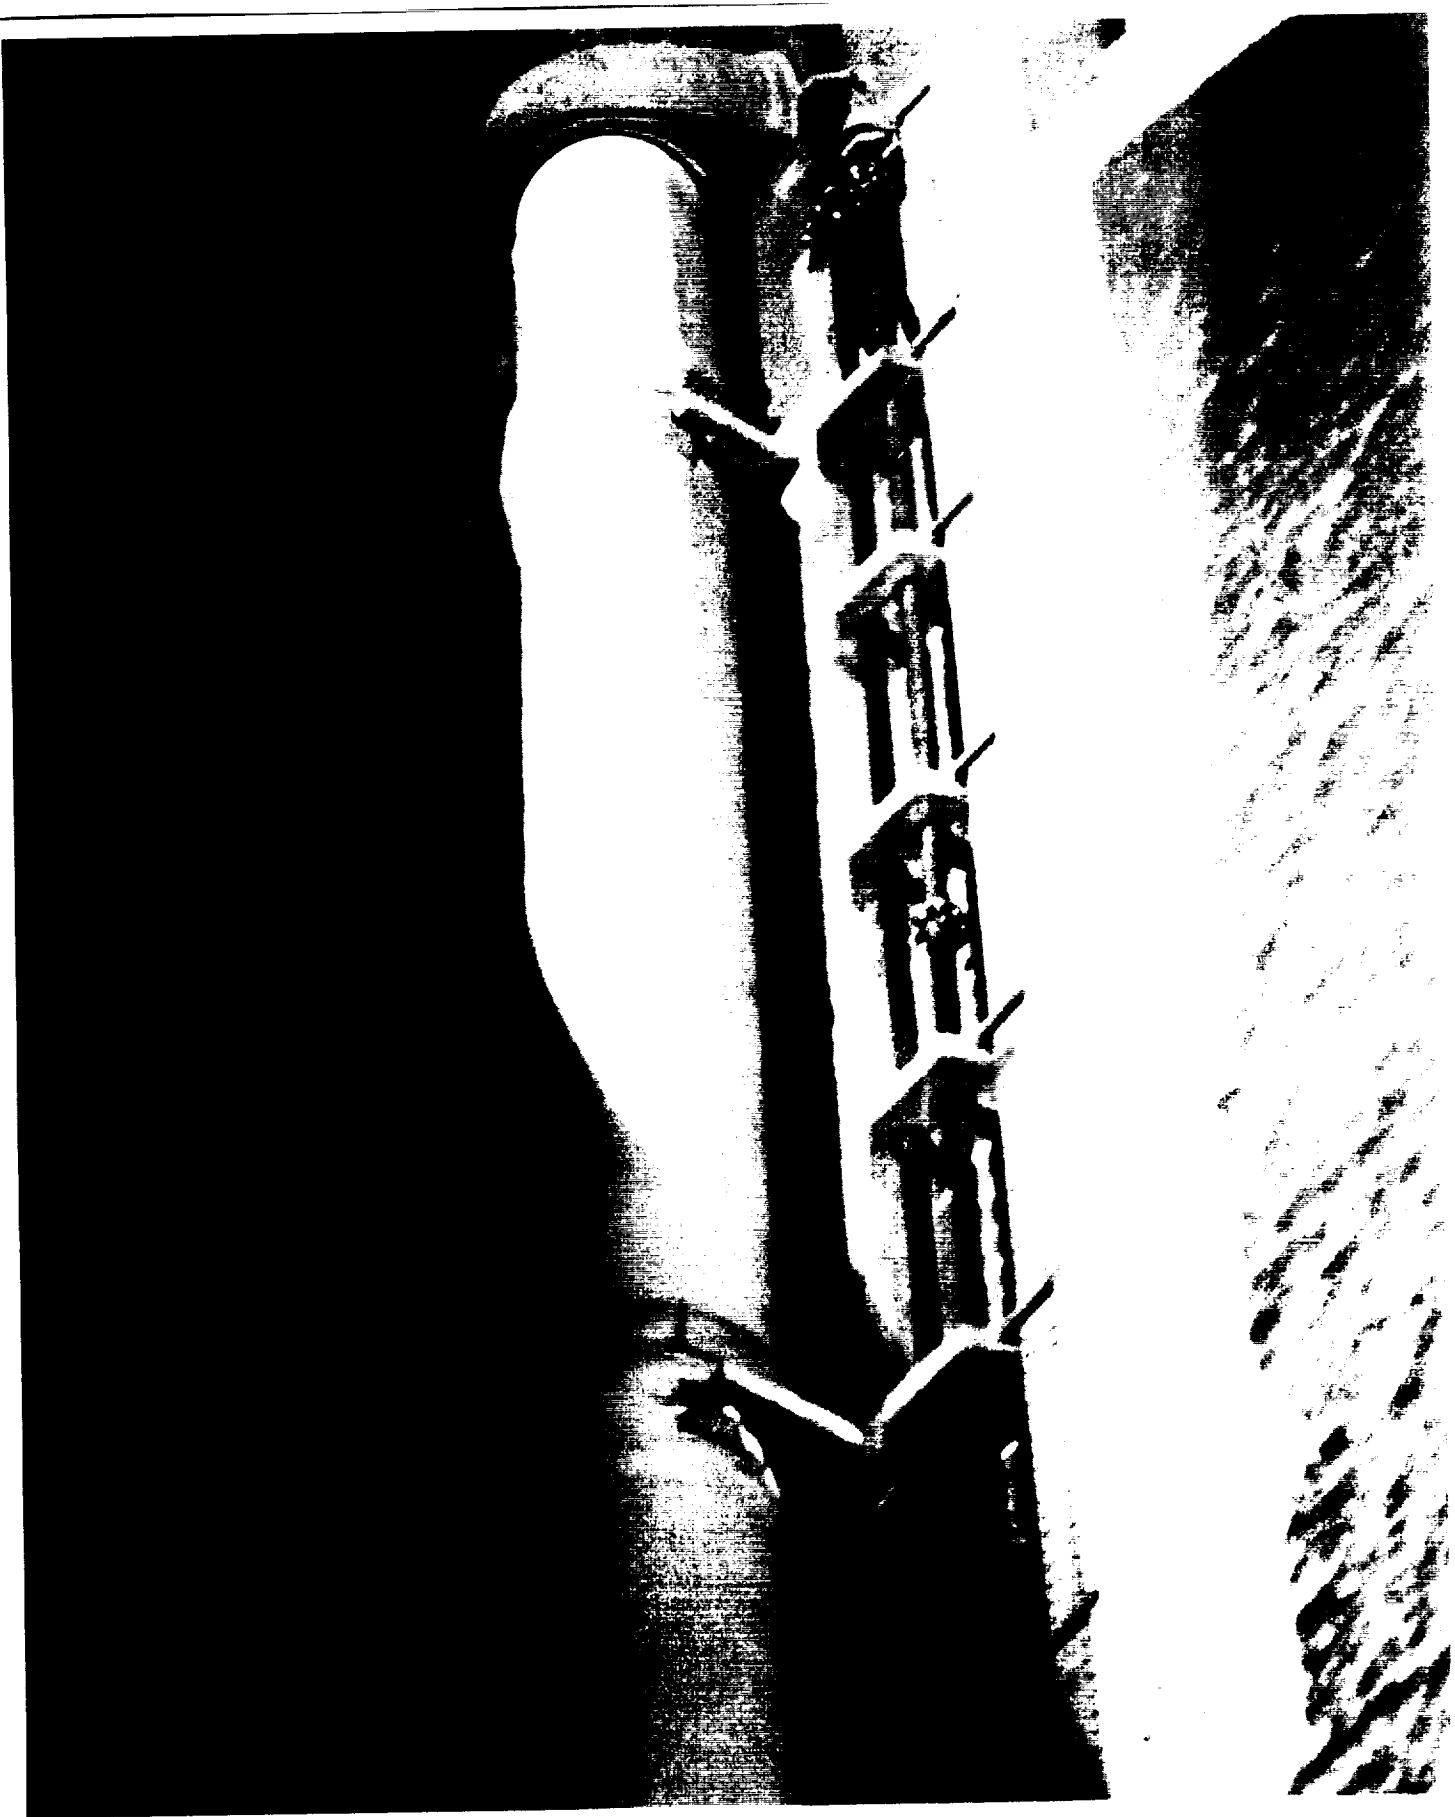
Ice/frost formed along the bondlines of the PAL ramp and some of the pressurization line/cable tray ramps. Ice/frost was also present in the LO2 feedline upper bellows and support brackets.

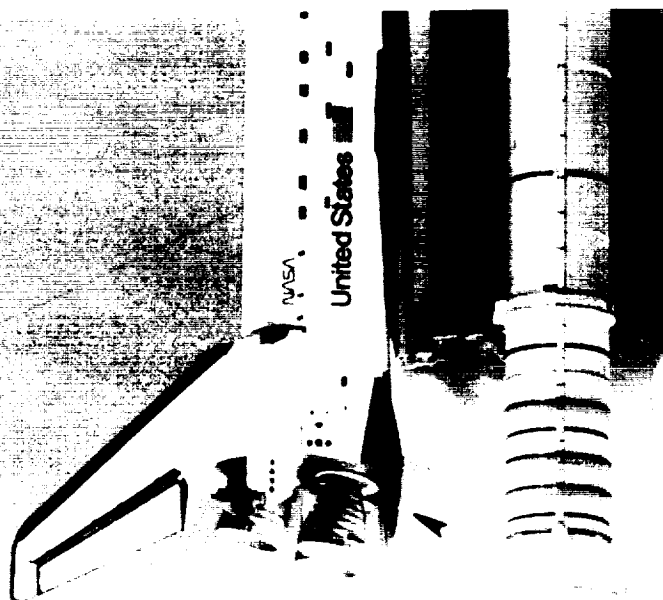
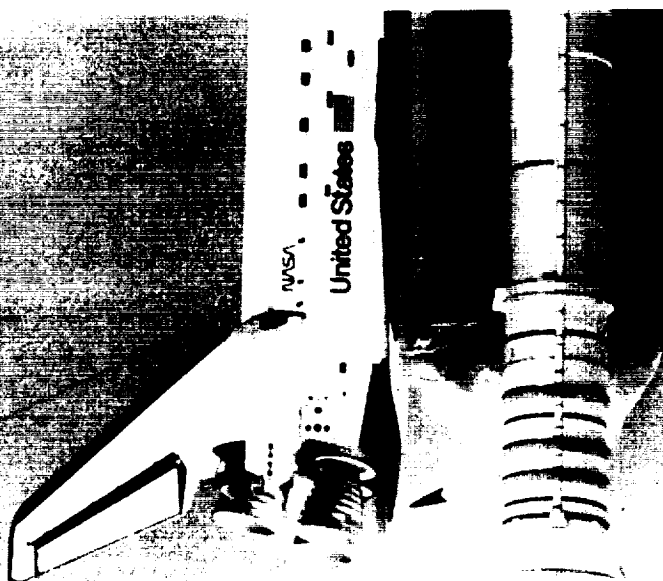
Ice continued to fall aft from the ET/ORB umbilicals as the vehicle cleared the tower. One piece impacted the Orbiter body flap (arrows), but no tile damage was visible.

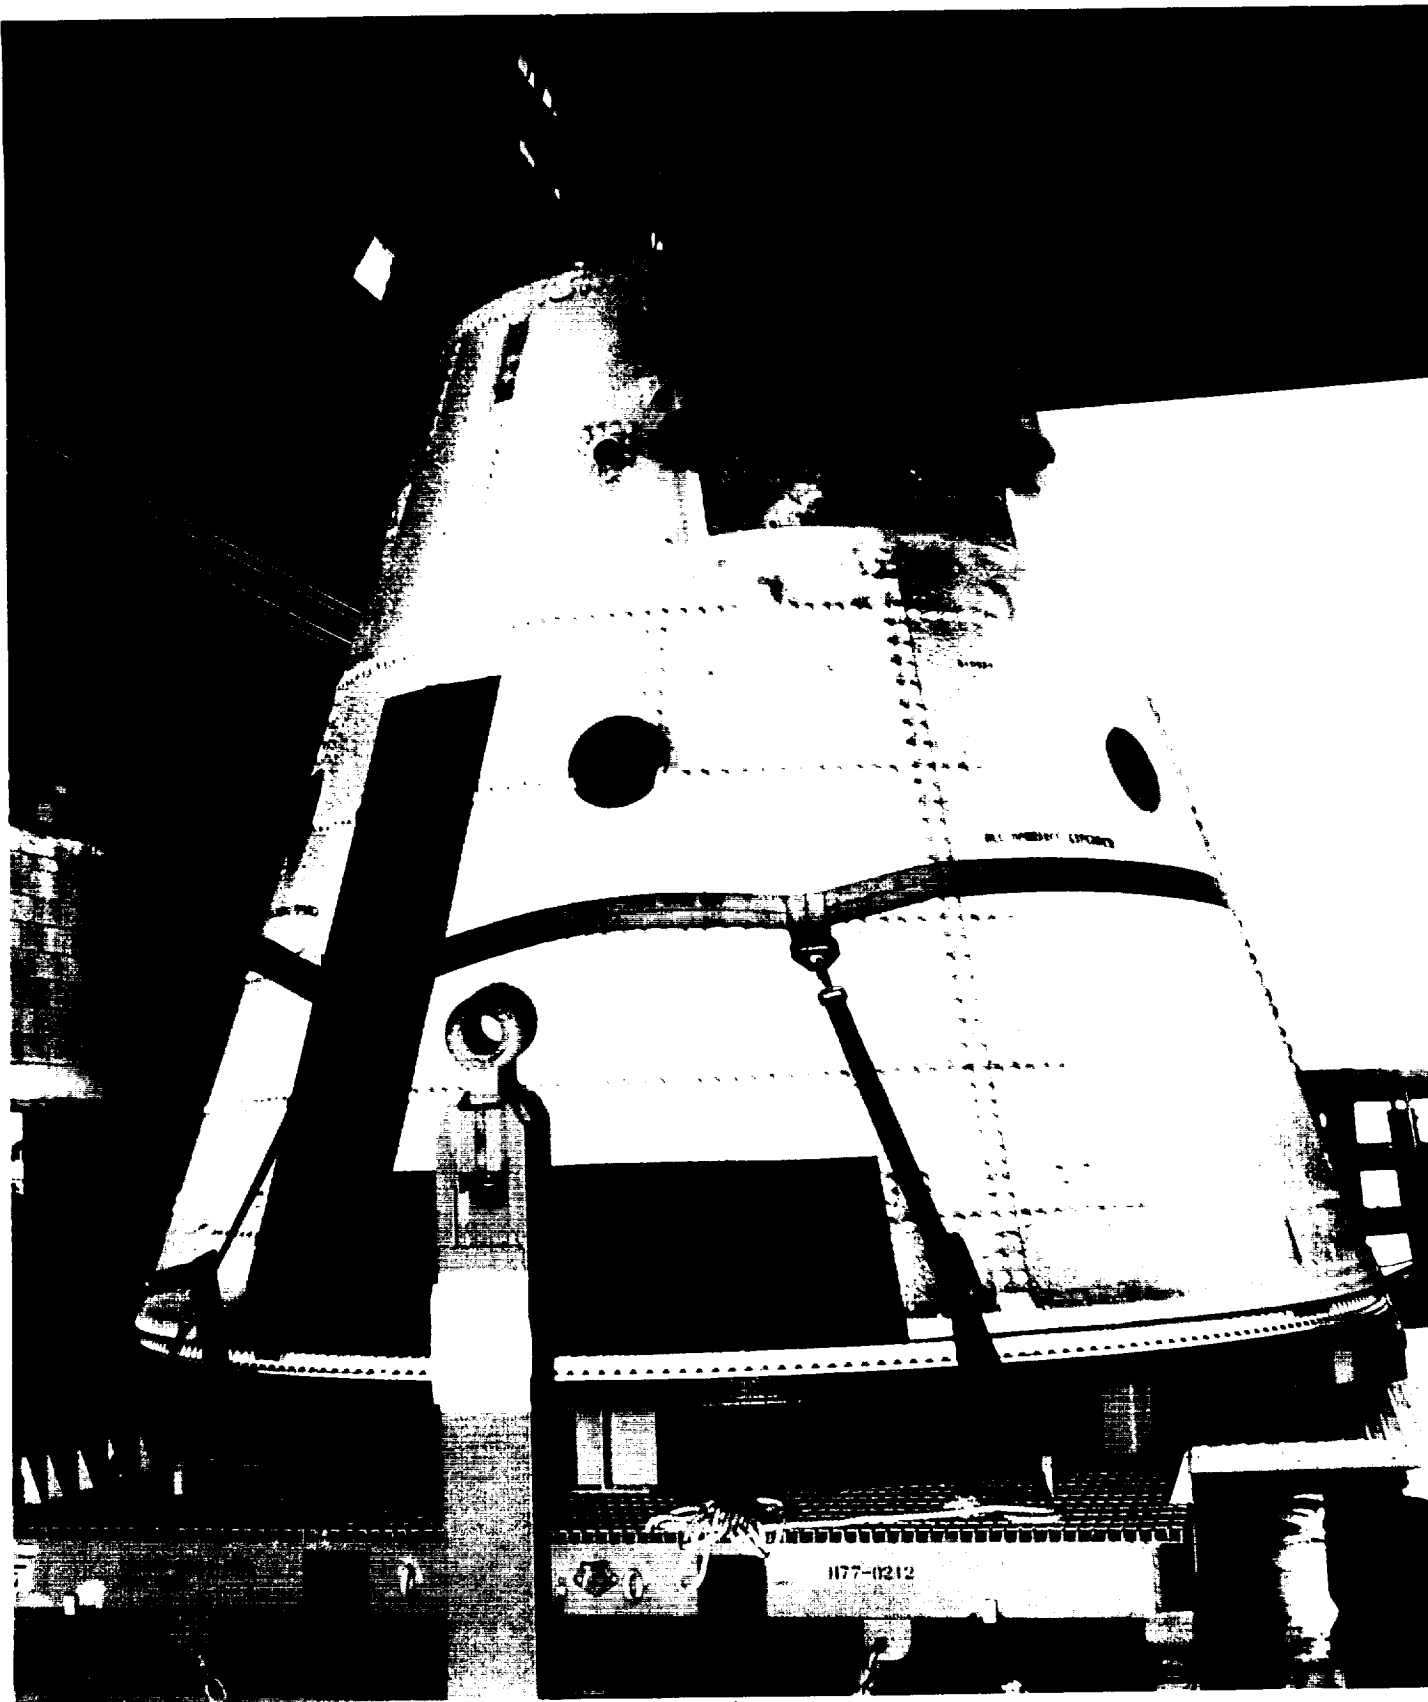
The RH frustum had 16 MSA-2 debonds over fasteners and one 1-inch diameter area of missing TPS between the +Y and -Z axes at the 381 ring frame. All BSM aero heat shield covers were locked in the fully opened position.

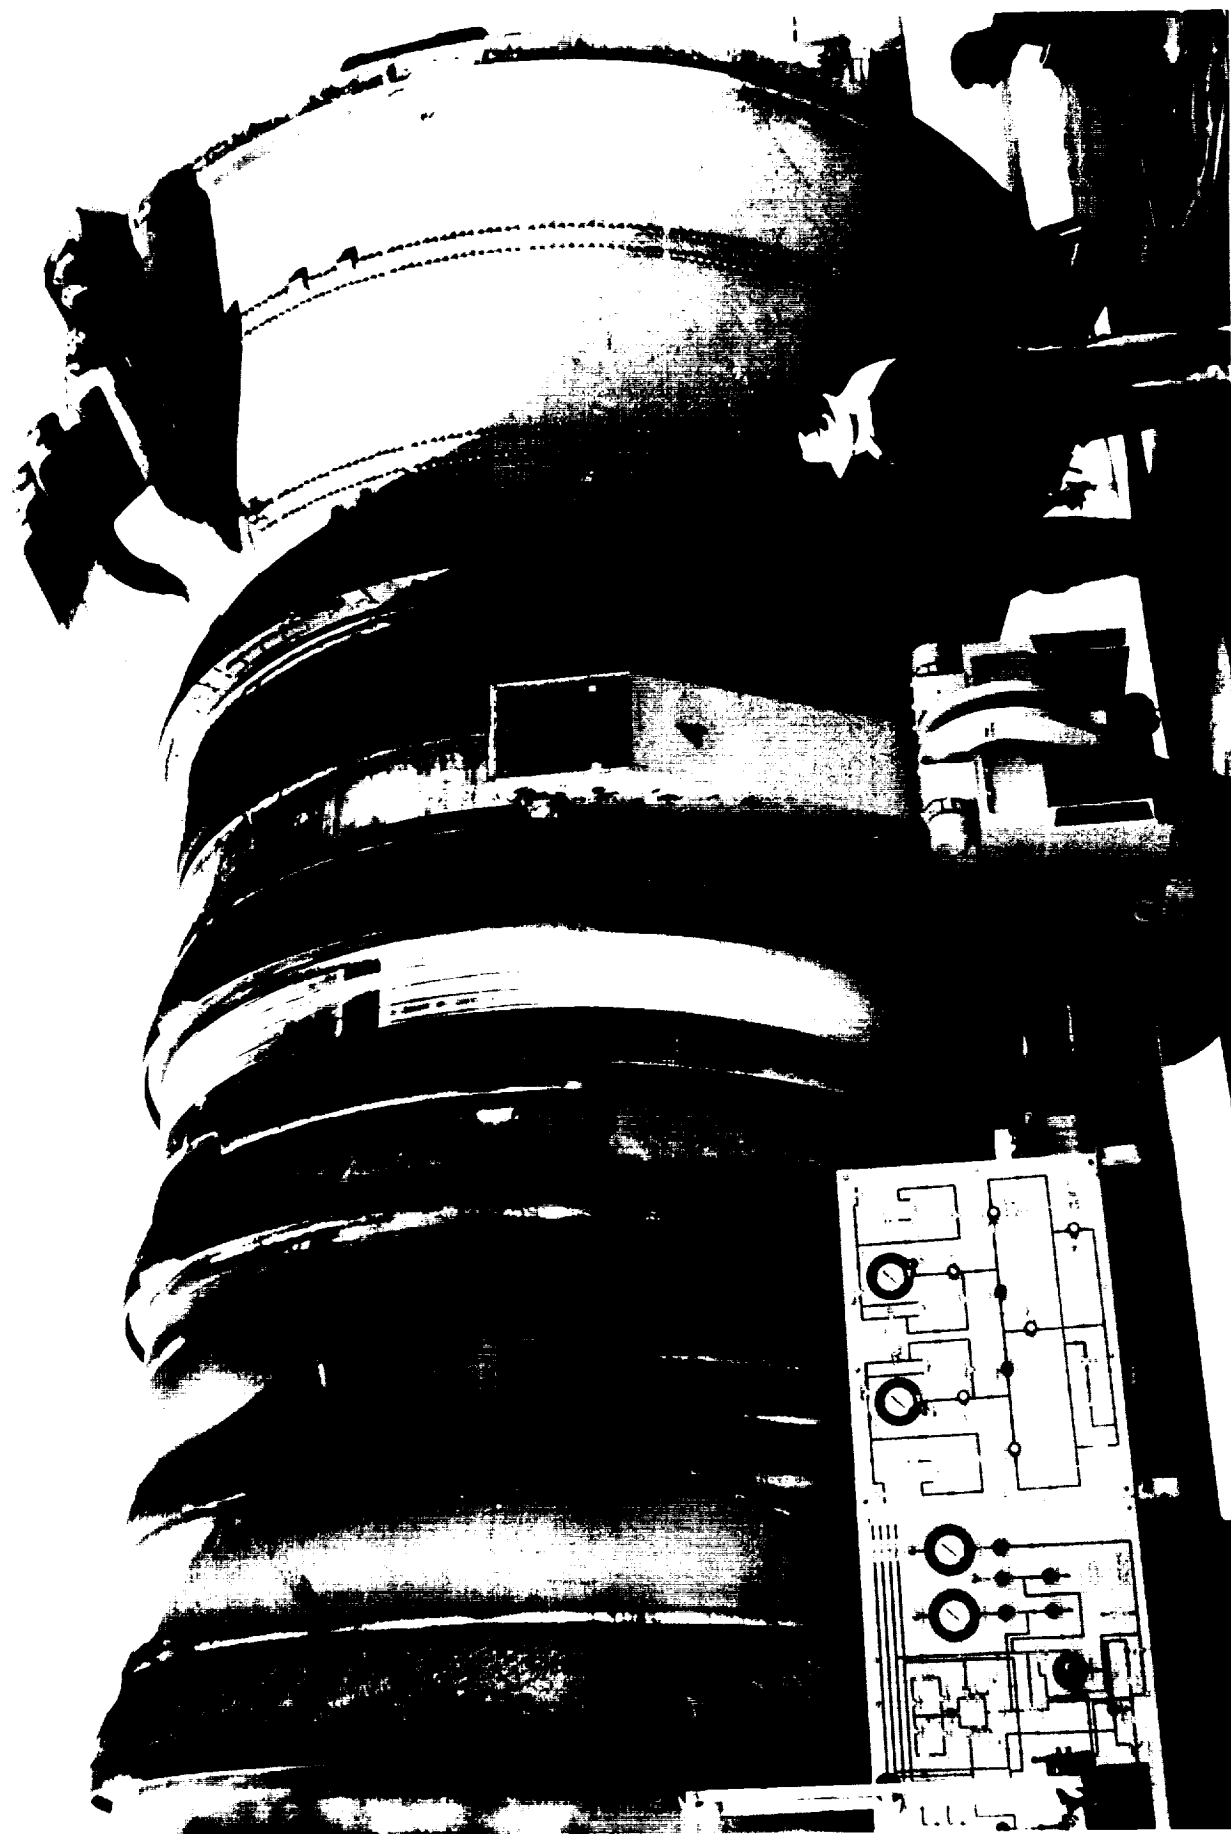
Post flight condition of the RH aft booster. Separation of the aft ET/SRB struts appeared normal. One divot, measuring 4 inches in diameter, had occurred over fasteners on the aft skirt TFS near holddown post #3.

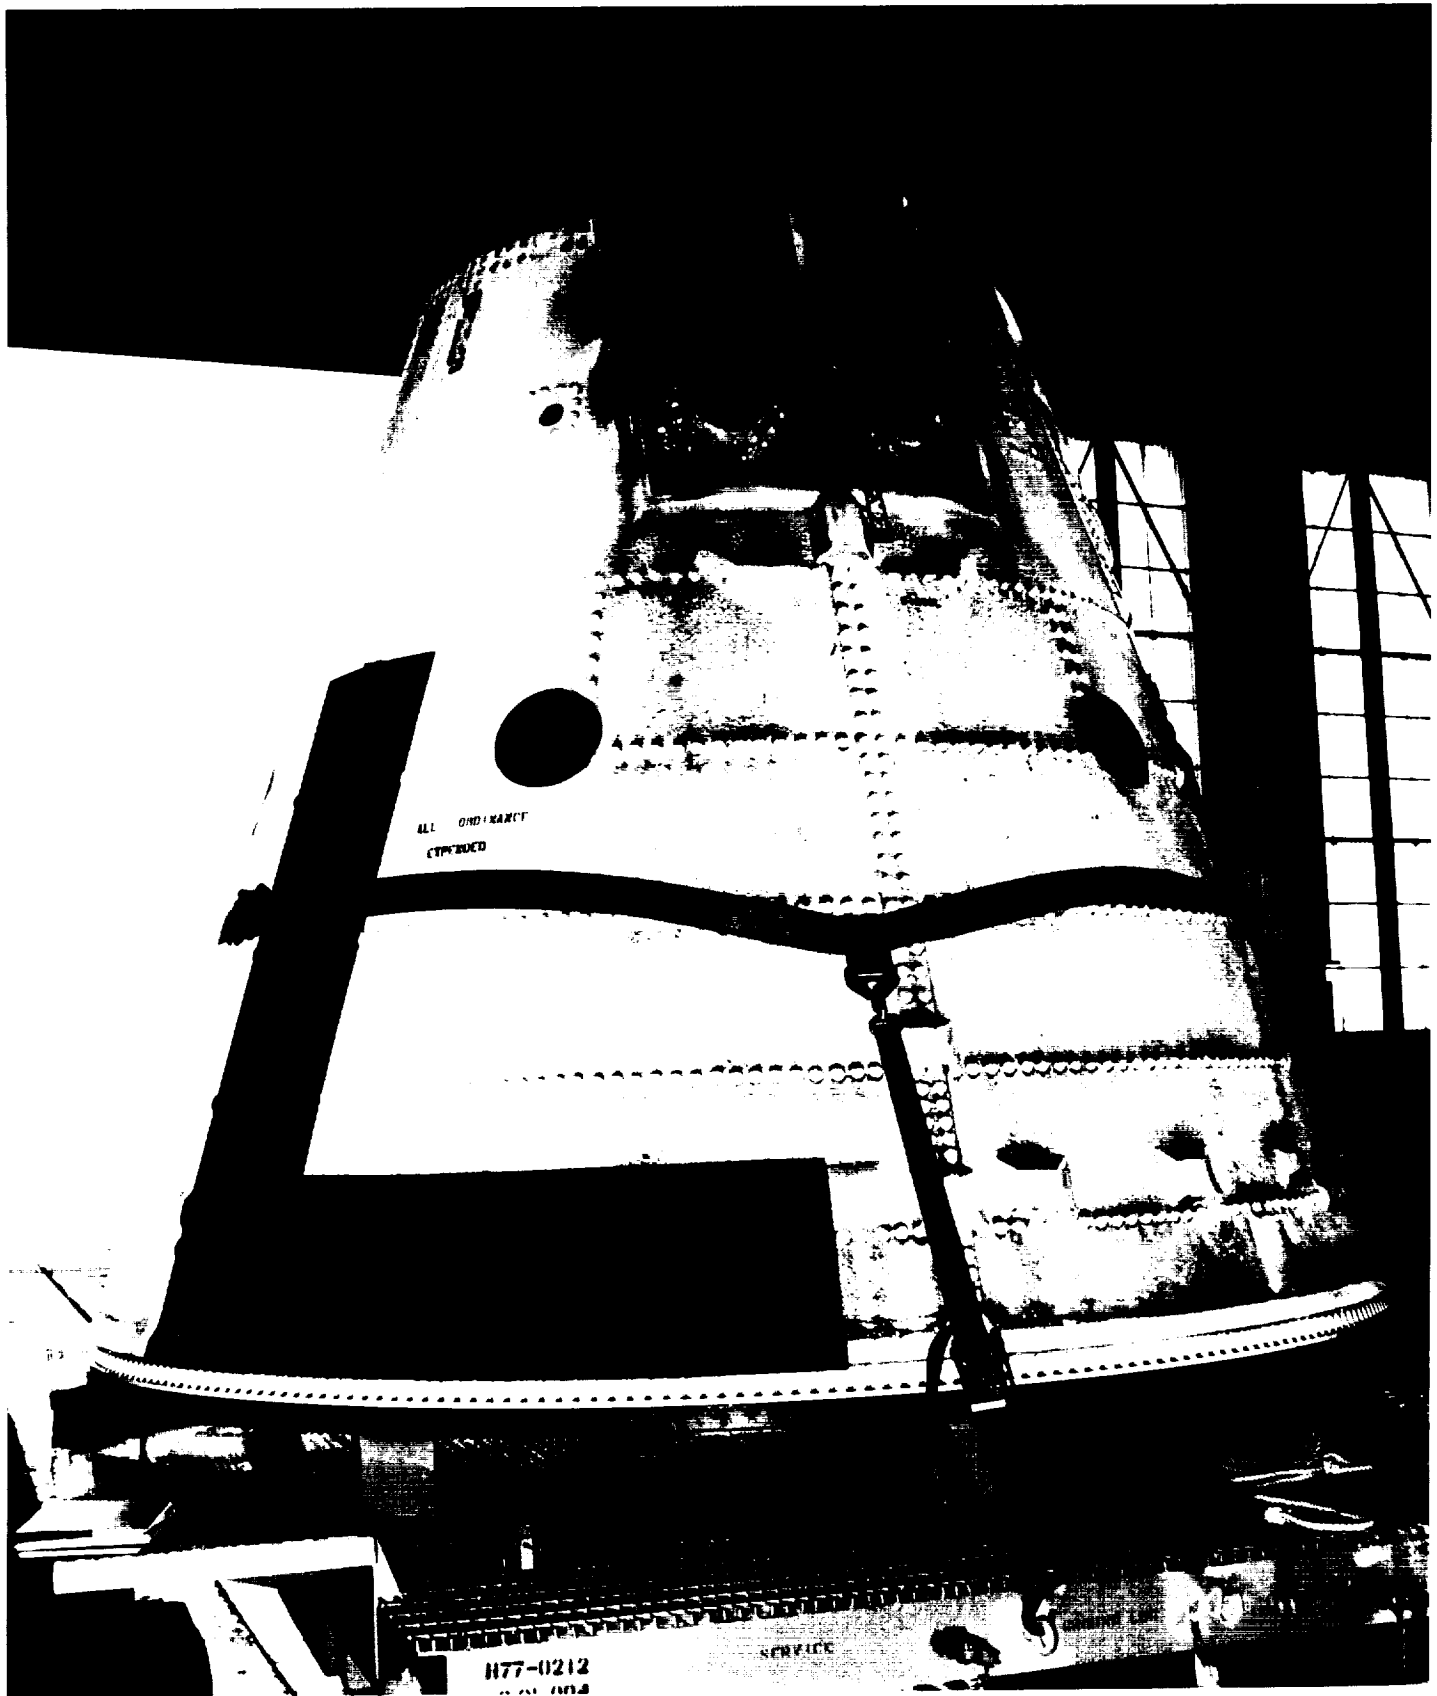
The LH frustum had 28 MSA-2 debonds over fasteners. The BSM aero heat shield covers were locked in the fully opened position, though three of the four cover attach rings had been bent by parachute riser entanglement.

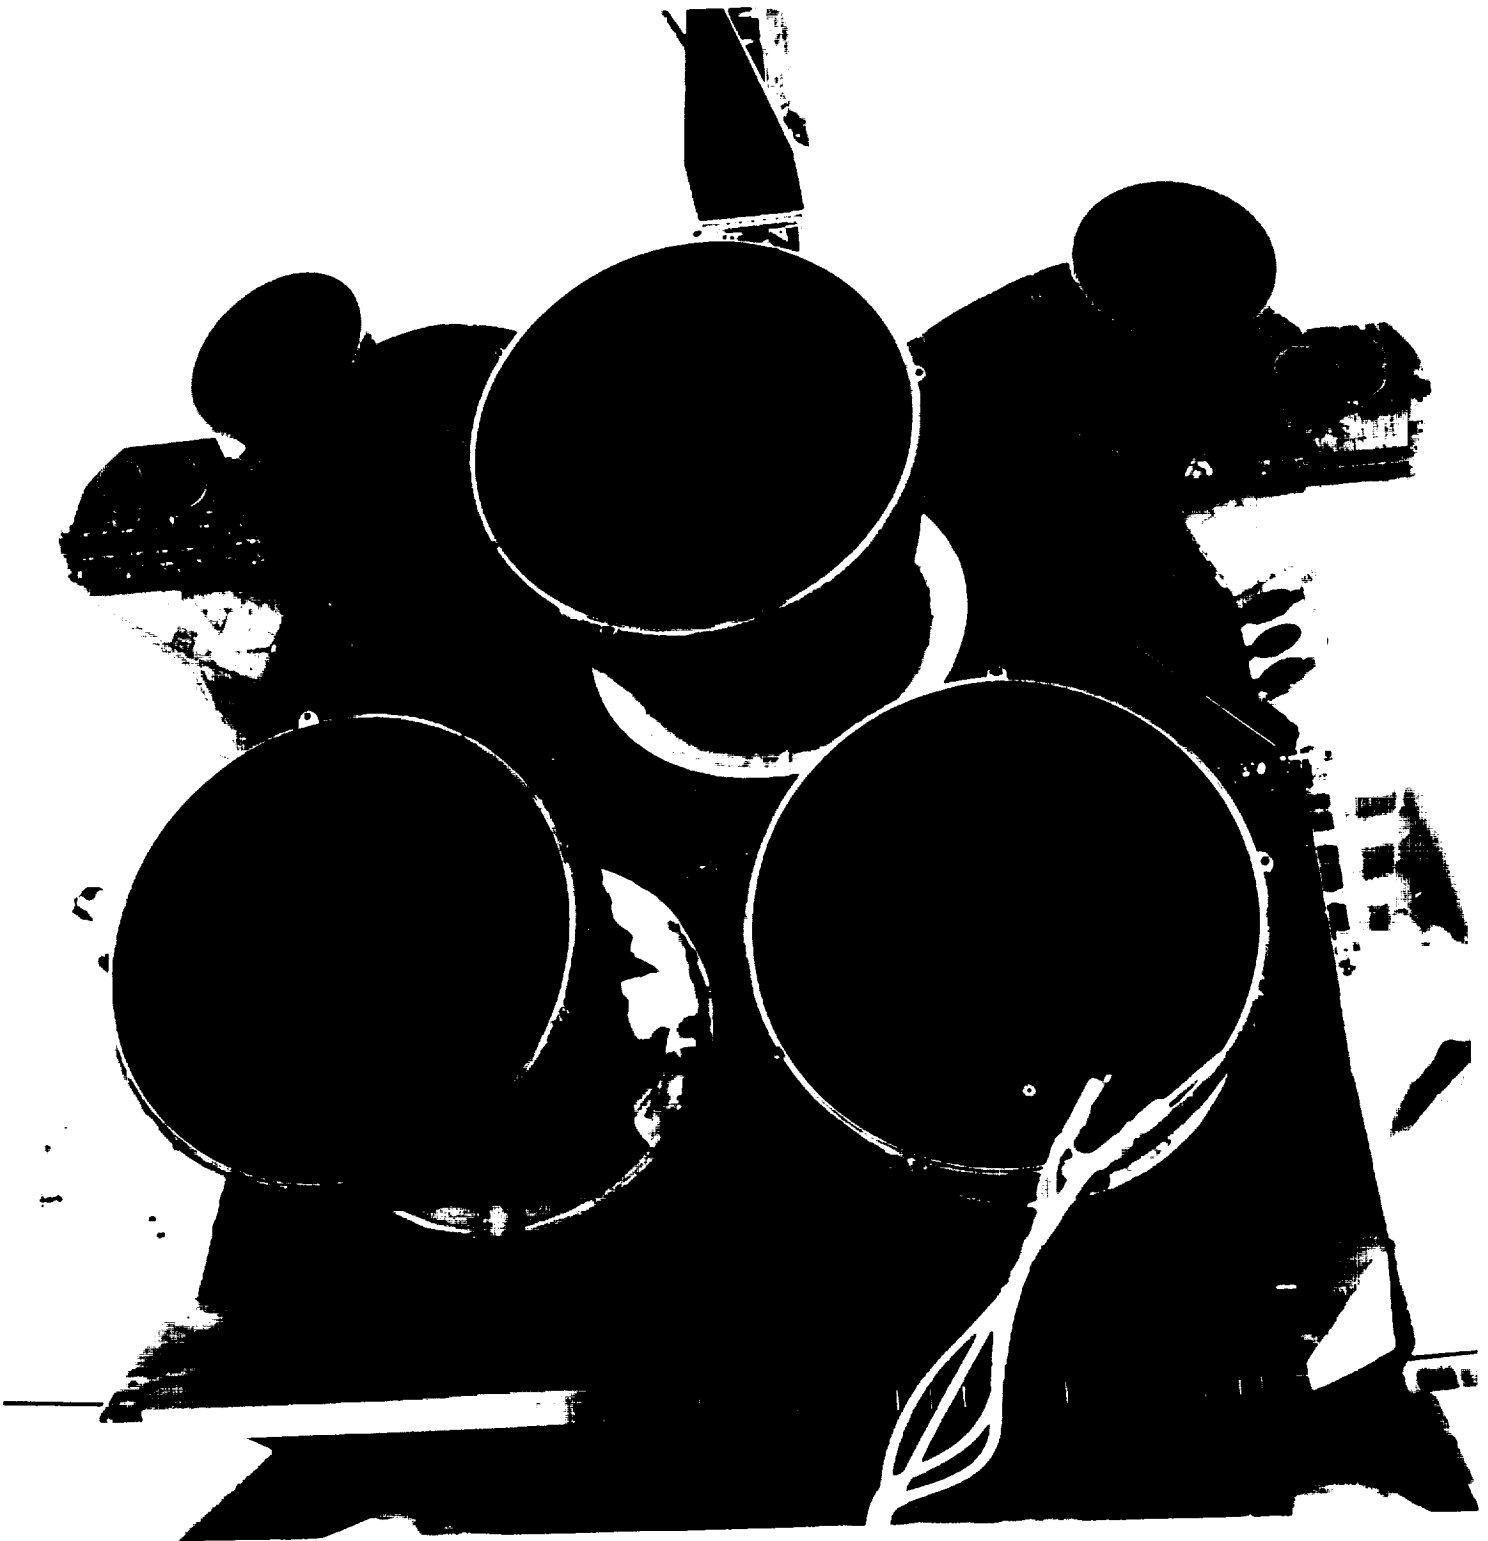
Tile damage on the base heat shield was typical. Four SSME #2 Dome Mounted Heat Shield closeout blanket sacrificial panels were nearly detached and the underlying batting material was exposed.

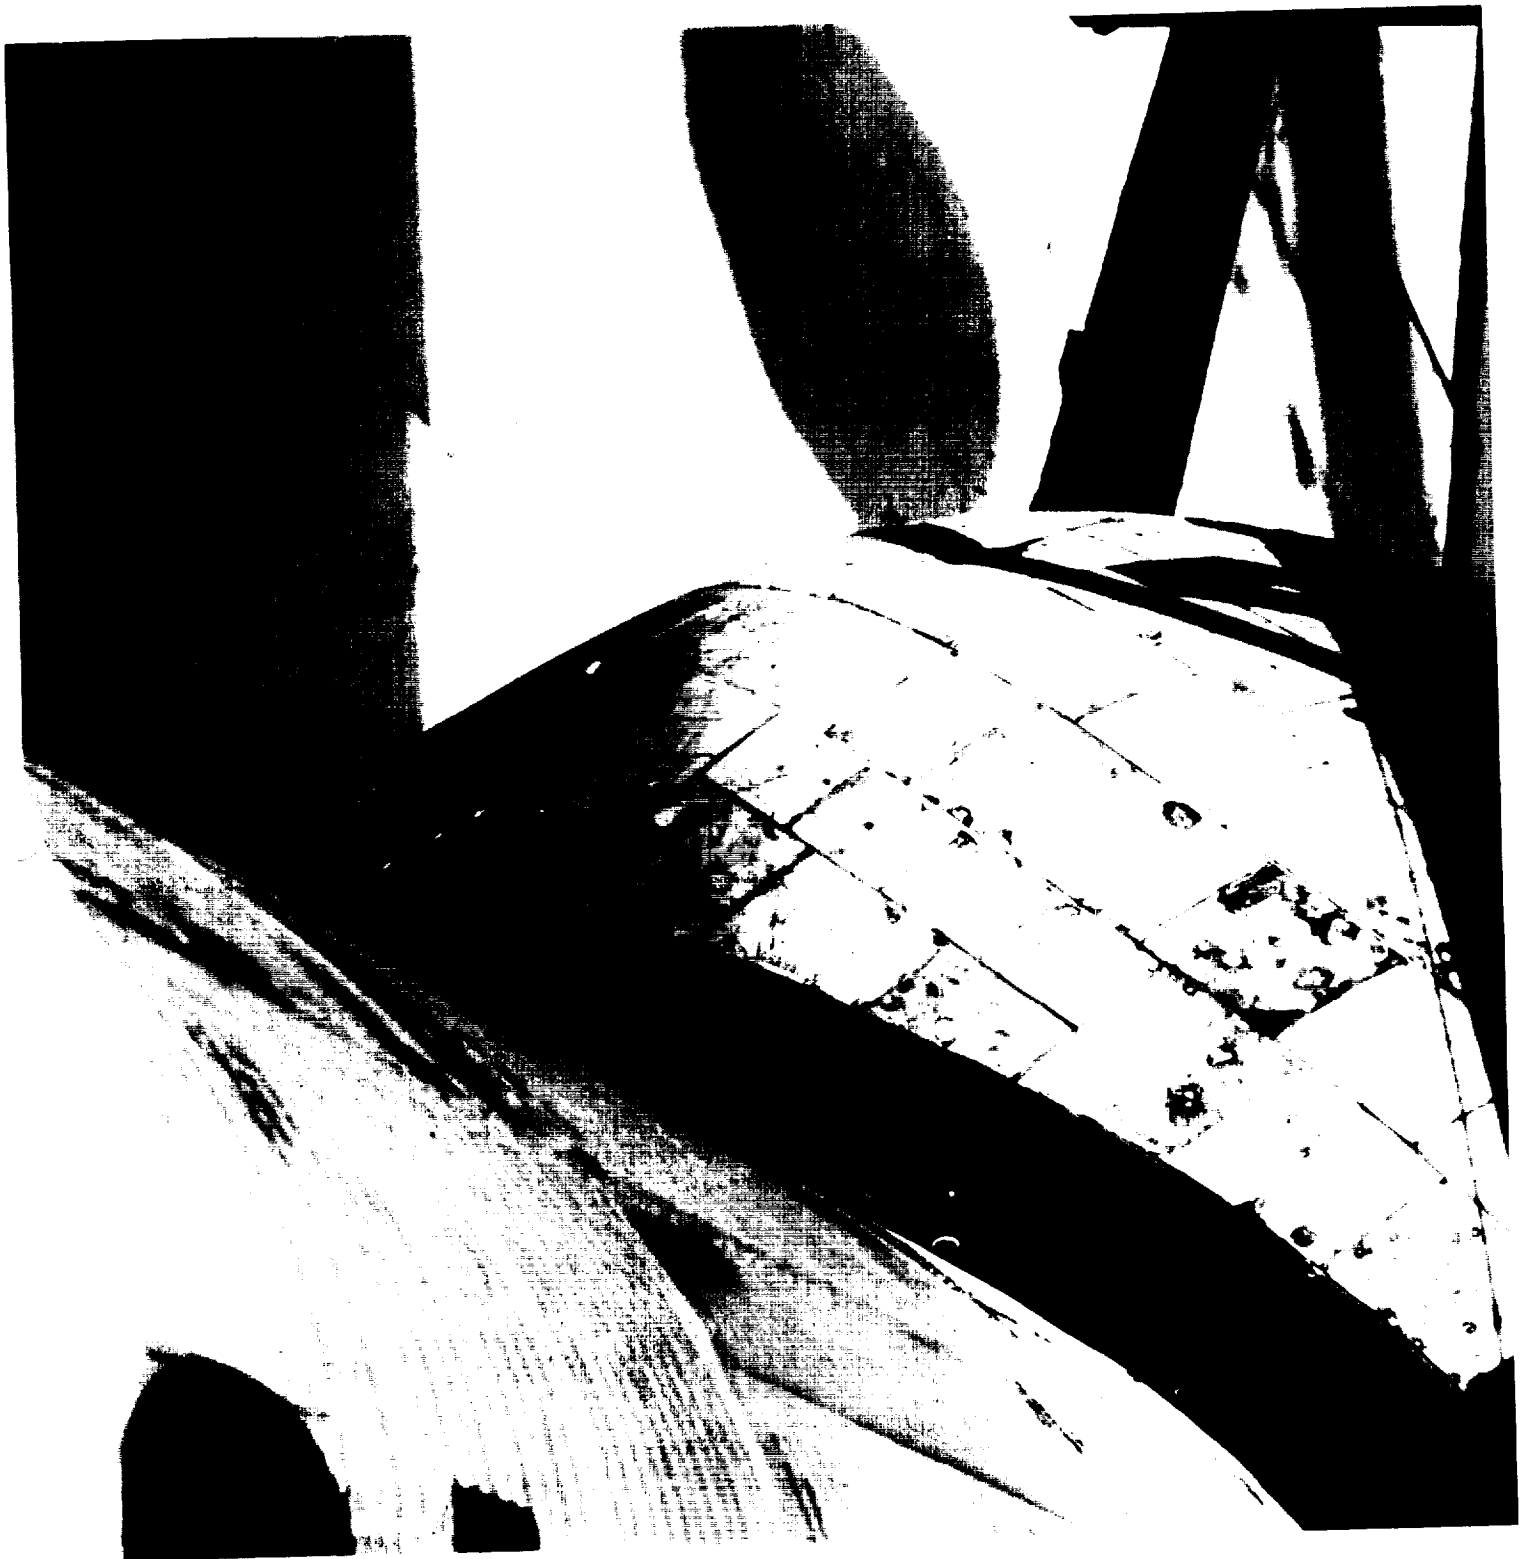
Tiles on the left OMS pod leading edge sustained more damage than usual. The cause of this damage is still undetermined.
